[Docket No. FAA-2011-1158; Directorate Identifier 2010-SW-018-AD;

Amendment 39-16847; AD 2011-22-05]

Airworthiness Directives; Eurocopter France Model AS350B, B1, B2, B3, BA, C, D, and D1; and AS355E, F, F1, F2, N, and NP Helicopters

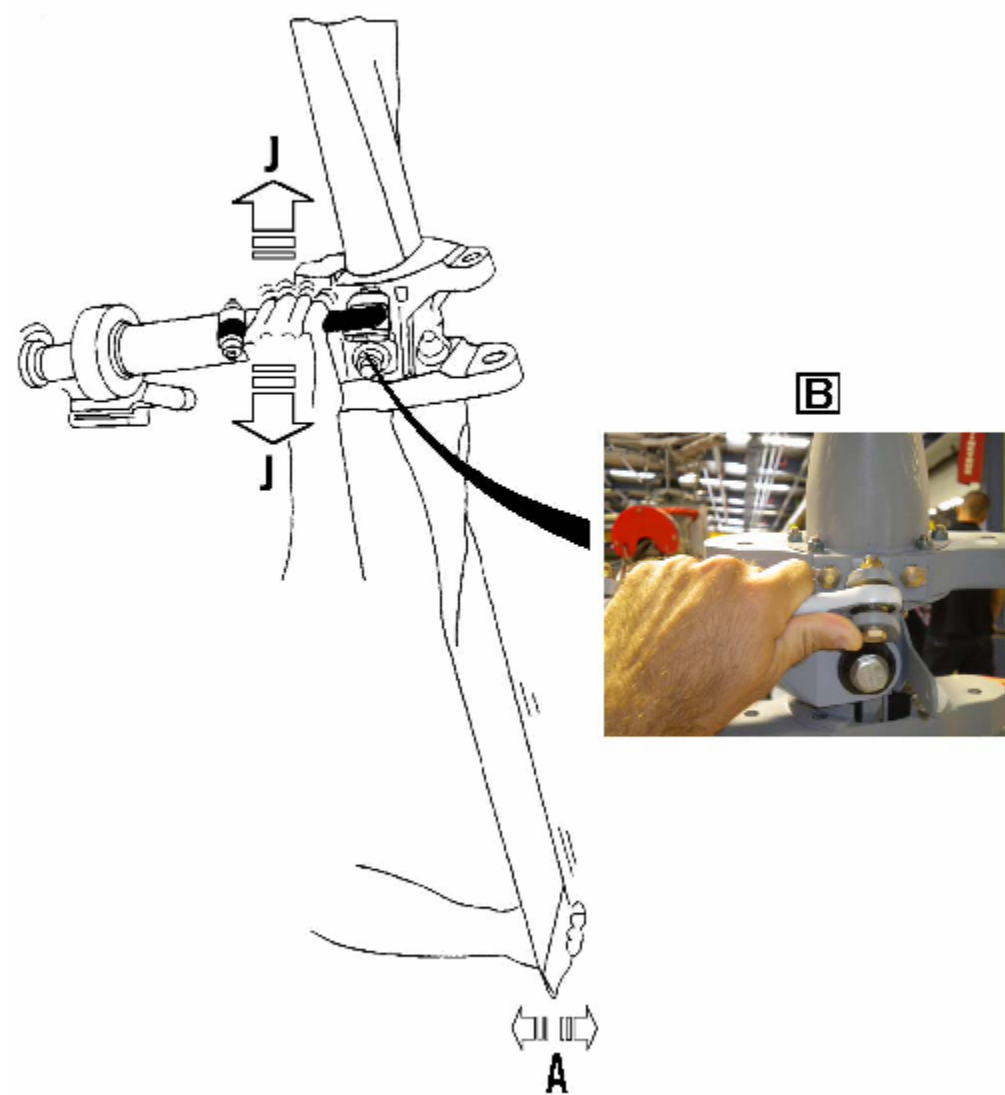
Figure 1: Manual Check for Play of the Tail Rotor Pitch Control Rod

(a) Before the first flight of each day, place the T/R pedals in the neutral position. If the helicopter is fitted with a T/R load compensator, discharge the accumulator as described in the rotorcraft flight manual. Check the control rod bearing (bearing) for play on the helicopter, by observation and feel, by slightly moving the T/R blade in the flapping axis while monitoring the bearing for movement. See the following Figure 1 of this AD. The actions required by this paragraph may be performed by the owner/operator (pilot) holding at least a private pilot certificate, and must be entered into the helicopter maintenance records showing compliance with this AD in accordance with 14 CFR §§ 43.9(a)(1)-(4) and 14 CFR §§ 91.417(a)(2)(v). The record must be maintained as required by 14 CFR §§ 91.173, 121.380, or 135.439.

(b) If the Teflon cloth is coming out of its normal position within the bearing, totally or partially, or if there is discoloration or scoring on the bearing, before further flight, replace the control rod with an airworthy control rod.

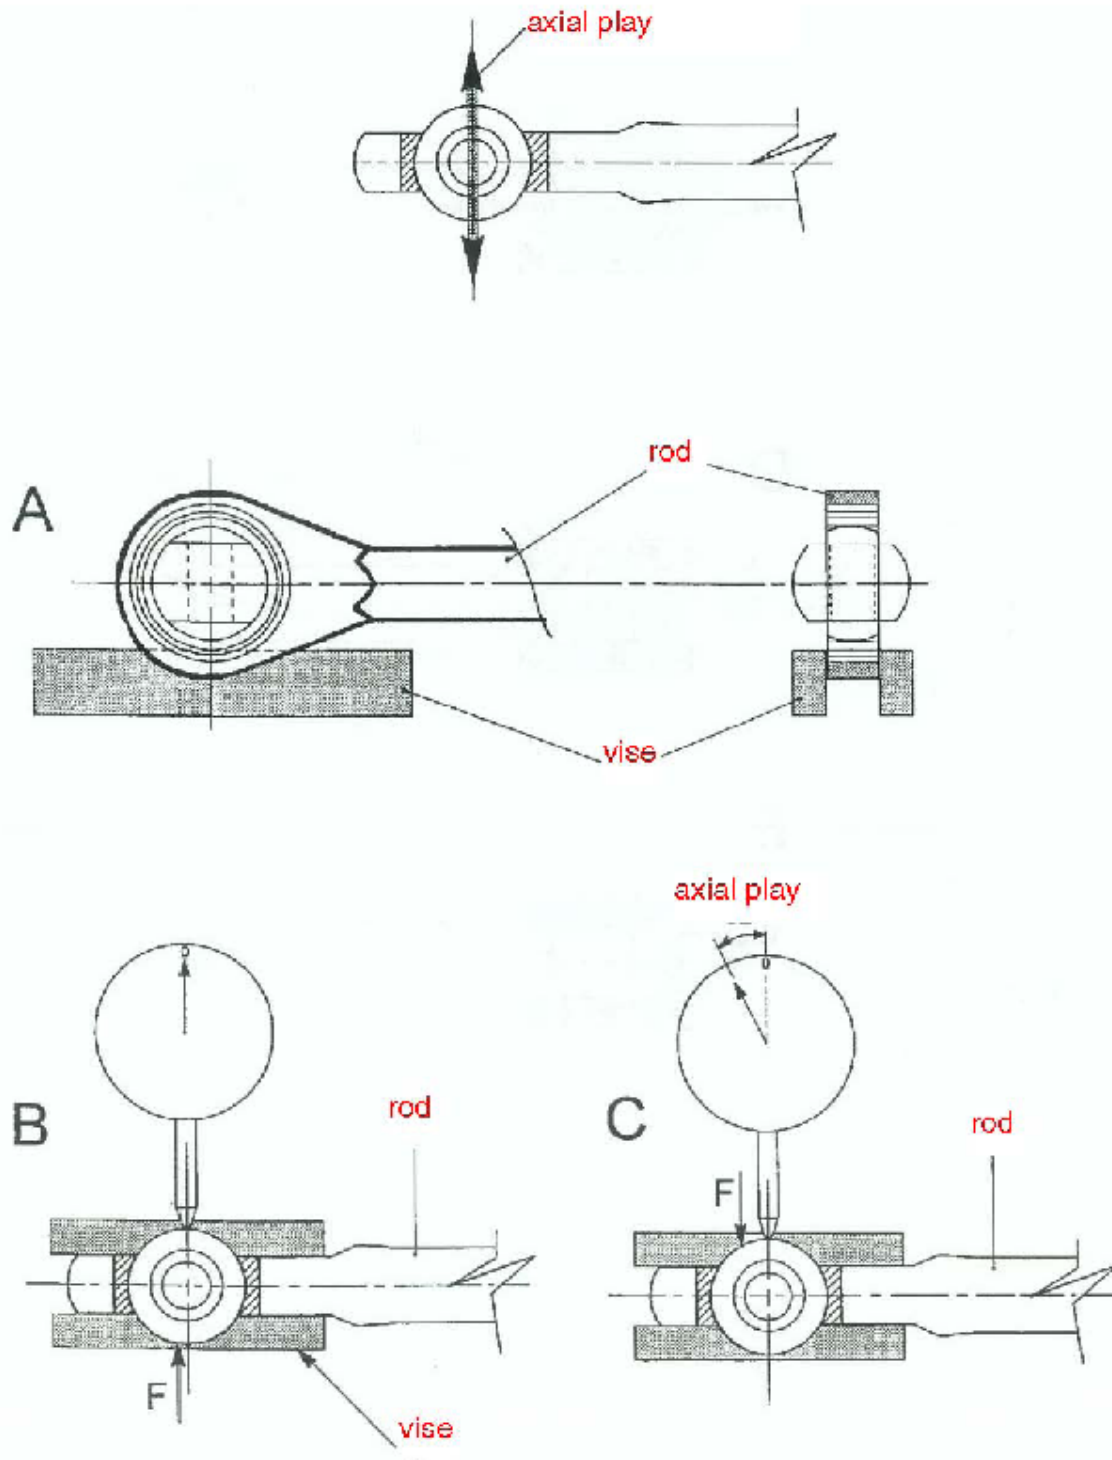
Figure 2: Measurement of the Axial Play (A) of the Bearing

(c) If a pilot or mechanic detects play, a mechanic must remove the control rod from the helicopter, and using a dial indicator, measure the bearing wear according to the following and as shown in Figures 2 and 3 of this AD:

- (1) Remove the control rod from the helicopter.
 - (2) Mount the control rod in a vise as shown in Figure 2 of this AD.
 - (3) Using a dial indicator, take axial play readings by moving the spherical bearing in the direction F (up and down) as shown in Figure 2 of this AD.

- (8) If the radial play exceeds 0.008 inch or axial play exceeds 0.016 inch, replace the control rod with an airworthy control rod before further flight.

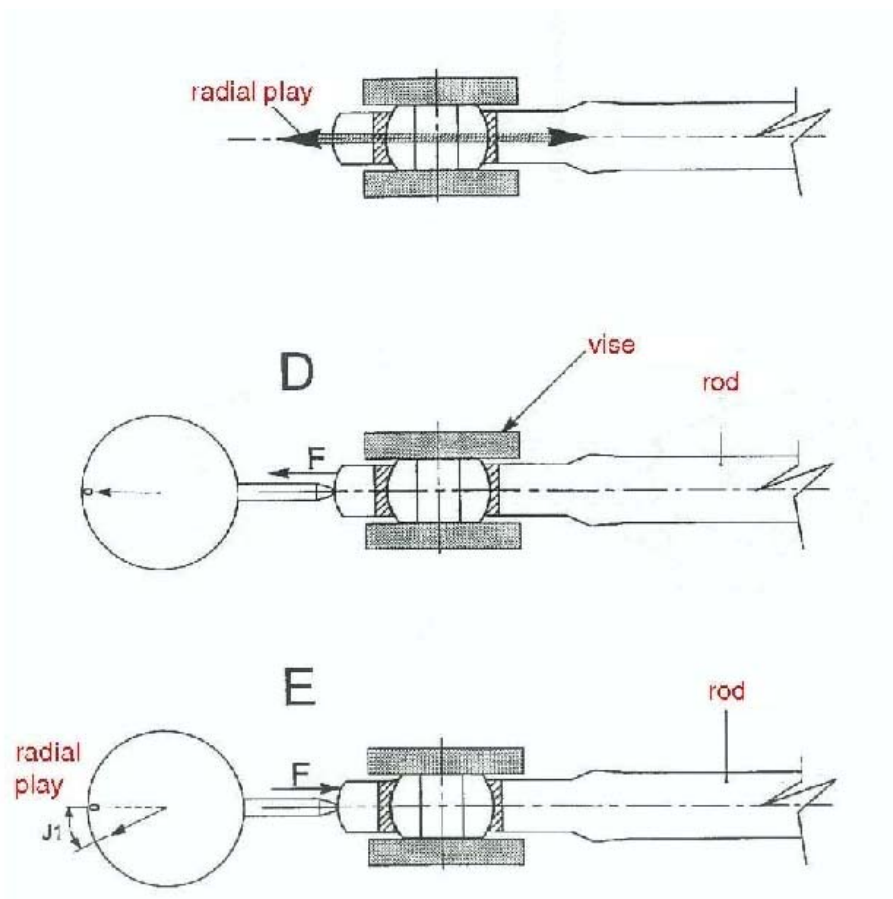
Figure 3: Measurement of the Radial Play (R) of the Bearing

- (4) Install a bolt through the bearing and secure it with a washer and nut to provide a clamping surface when the bearing is clamped in a vise.
 - (5) Mount the control rod and bearing in a vise as shown in Figure 3 of this AD.

- (6) Using a dial indicator, take radial play measurements by moving the control rod in the direction F as shown in Figure 3 of this AD.
 - (7) Record the hours of operation on each control rod.
